- » All bridges South of 190th St. (64 bridges total)
- » This year's findings General
- » This year's findings Key Findings
- » Key repair and replacement recommendations
- » Options for the way forward
- » GIS

2020 Bridge Safety Inspections

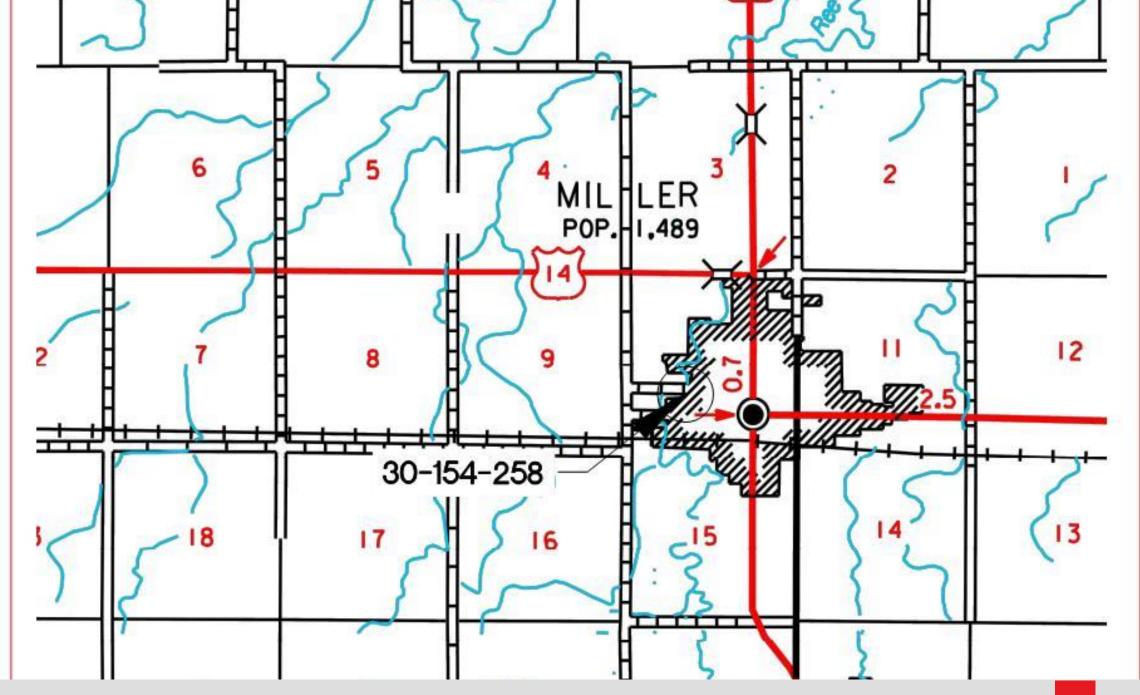
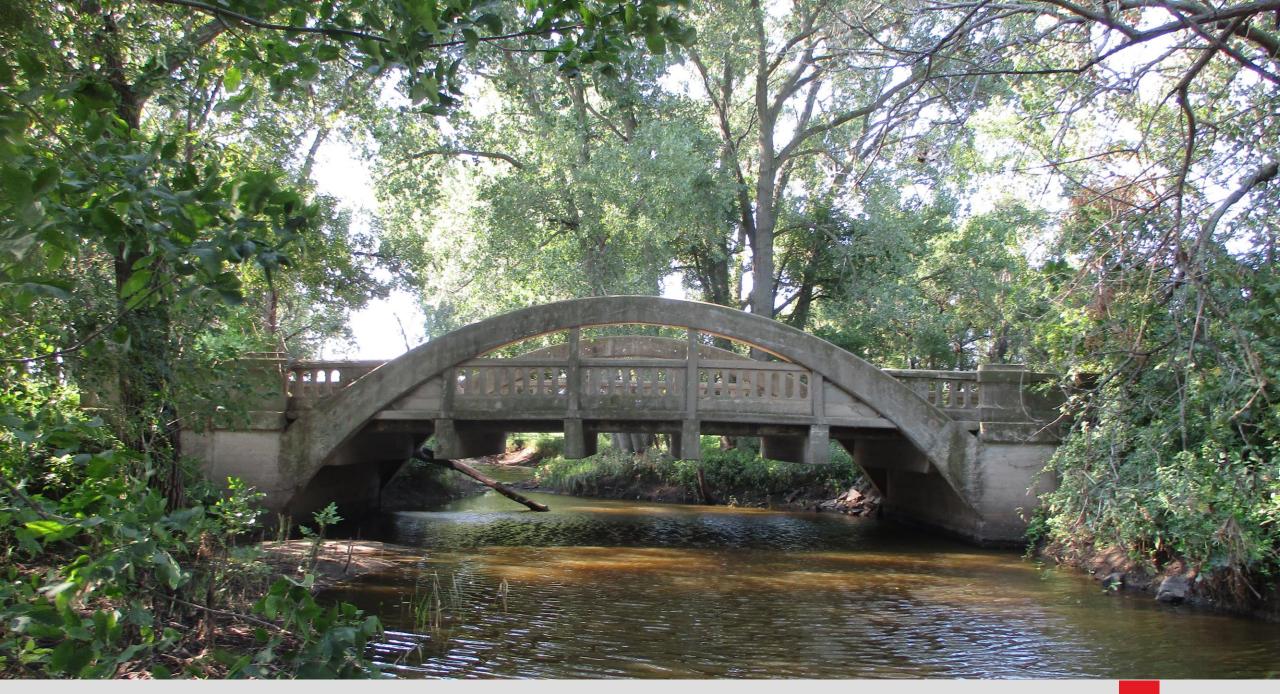
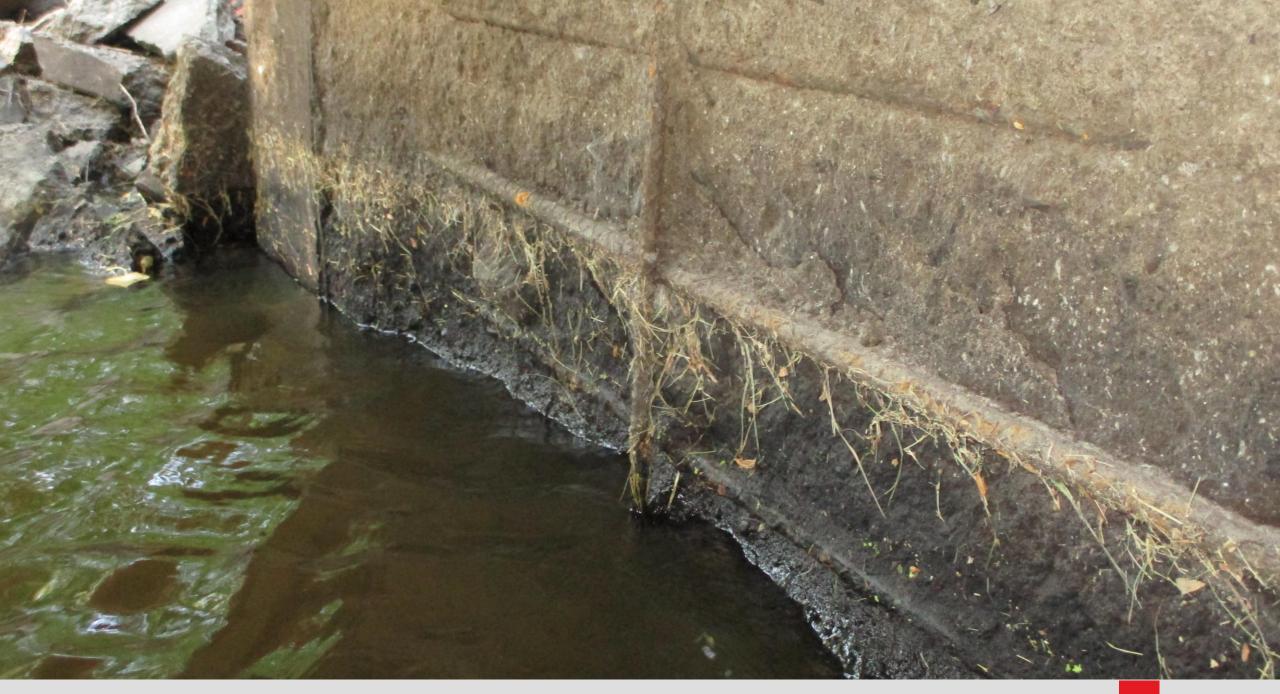
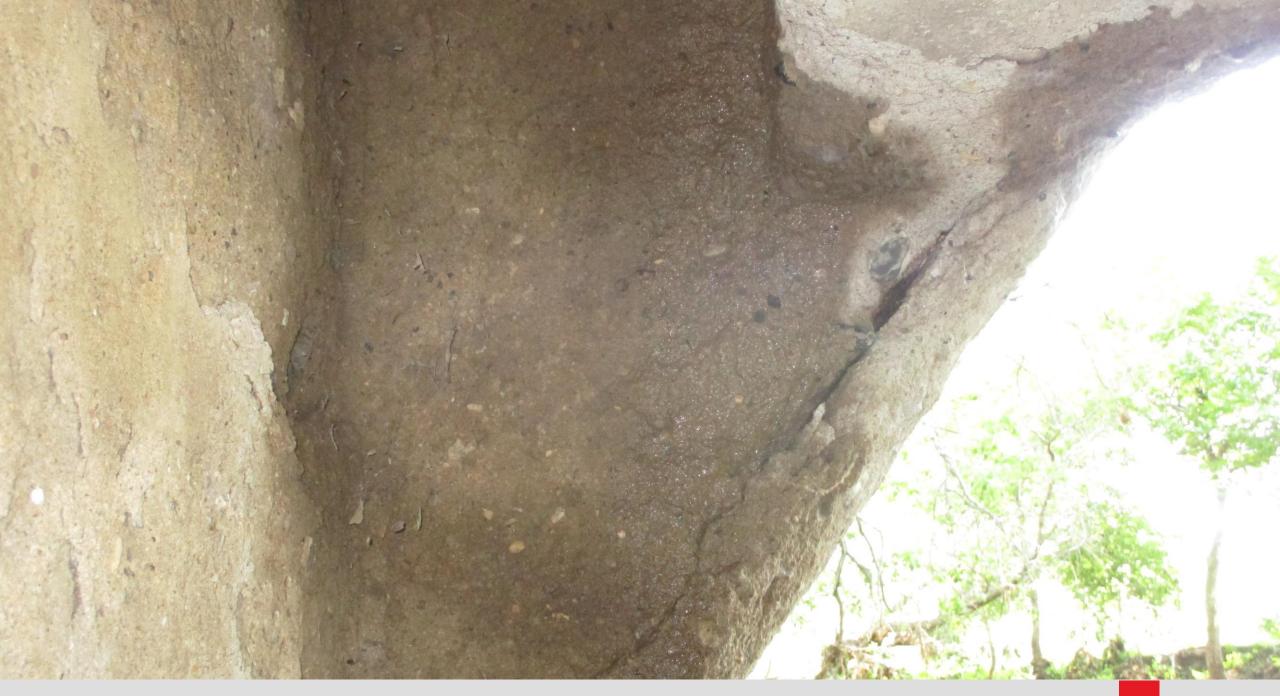
- » Major Repairs Recommended on 6 bridges (Cont.)
 - Bridge Number 30-154-258 (Concrete Arch) Historical Bridge BIG Rehab Grant Repair Concrete Substructure

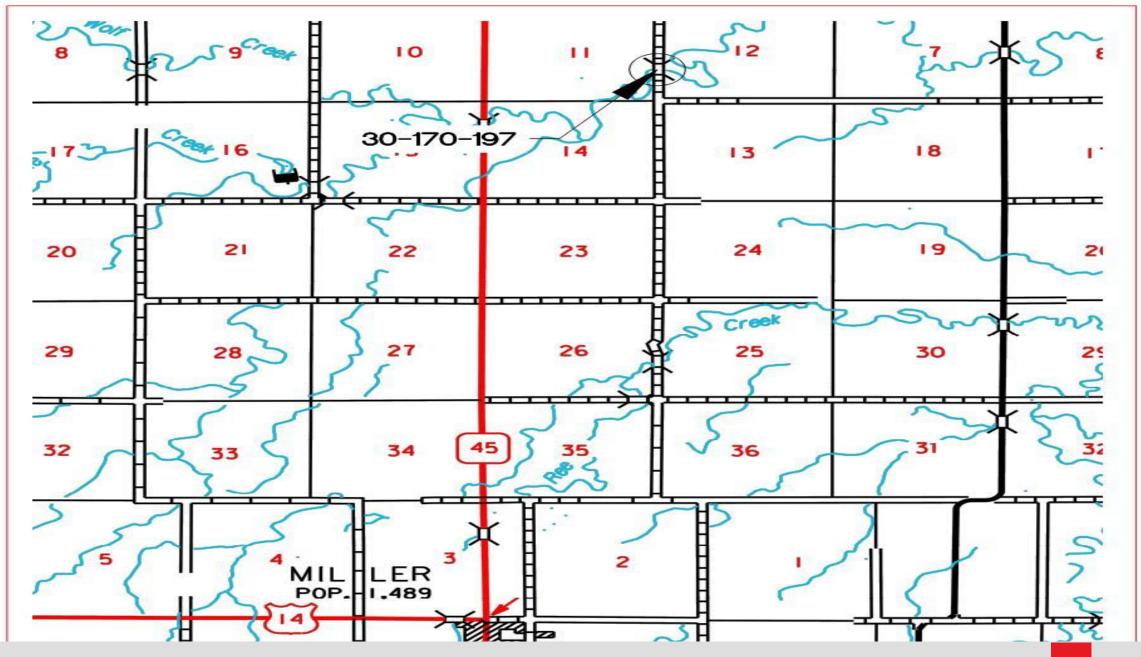
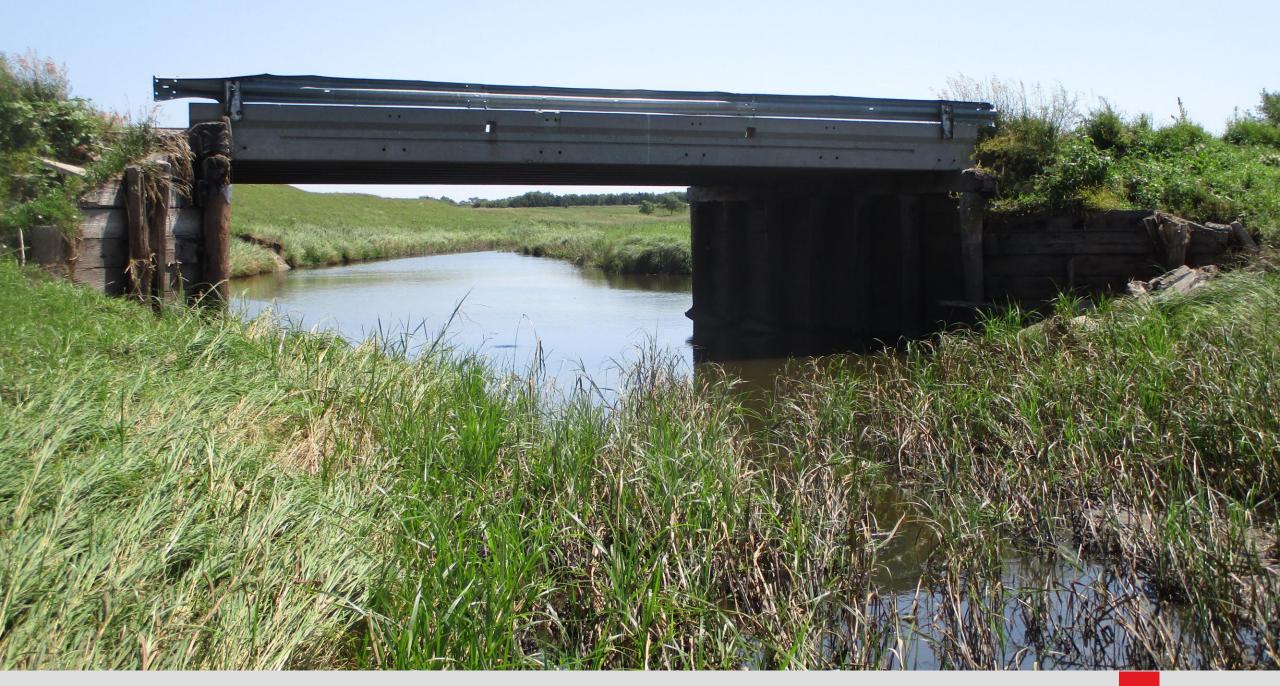
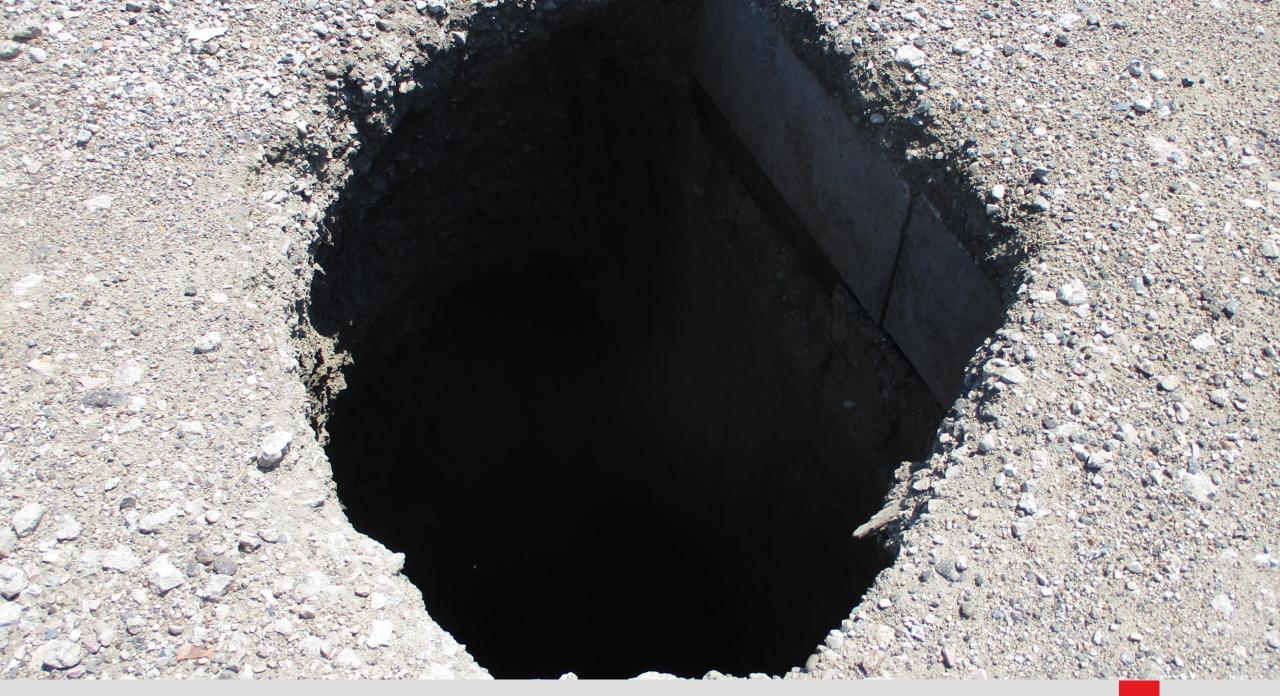
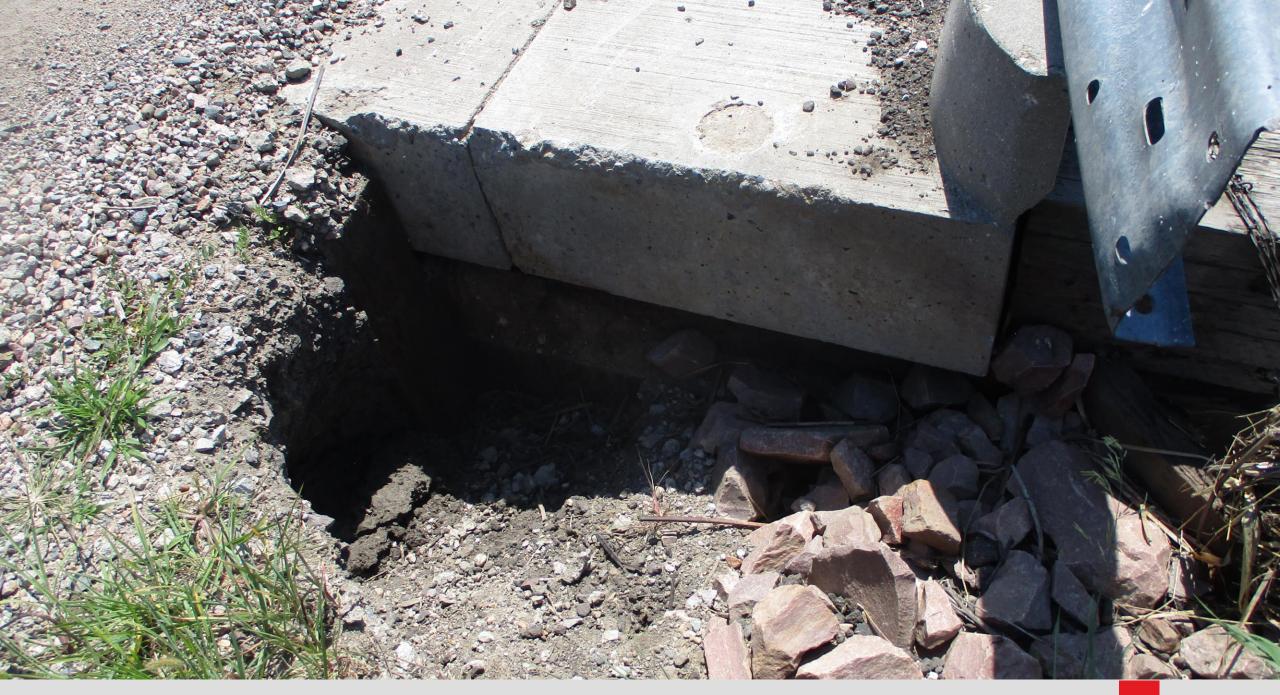
- » Major Repairs Recommended on 6 bridges (Cont.)
 - Bridge Number 30-170-197 (Double Tee/Timber Abut) Undermining of timber backwall has caused the roadway to collapse, riprap abutment and backfill roadway.

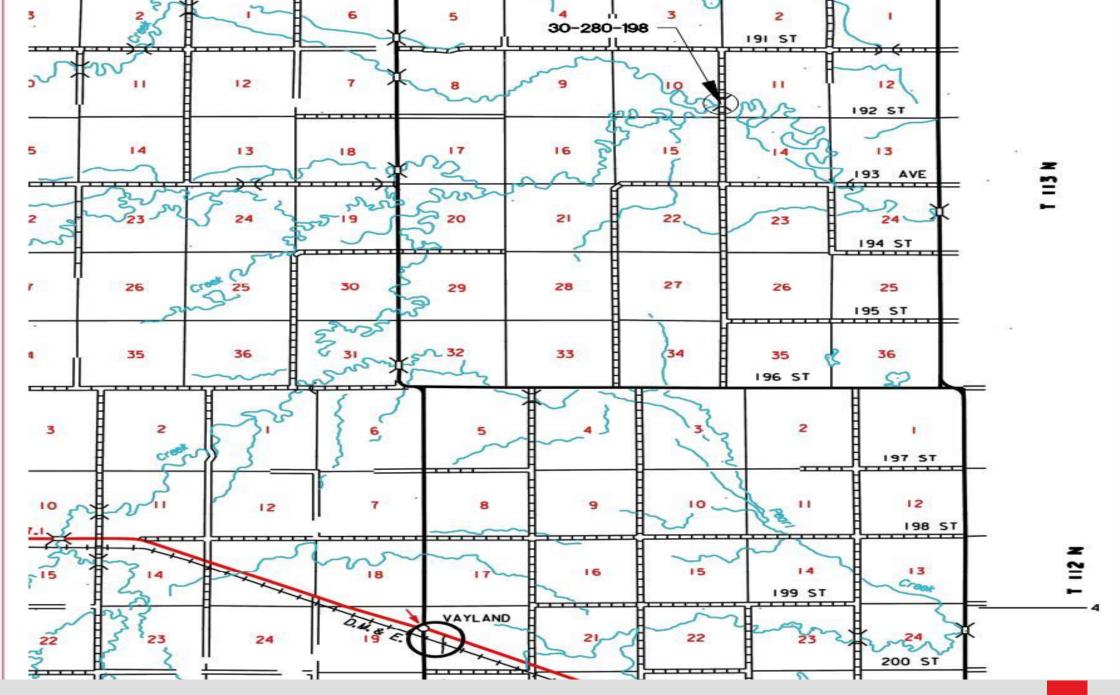
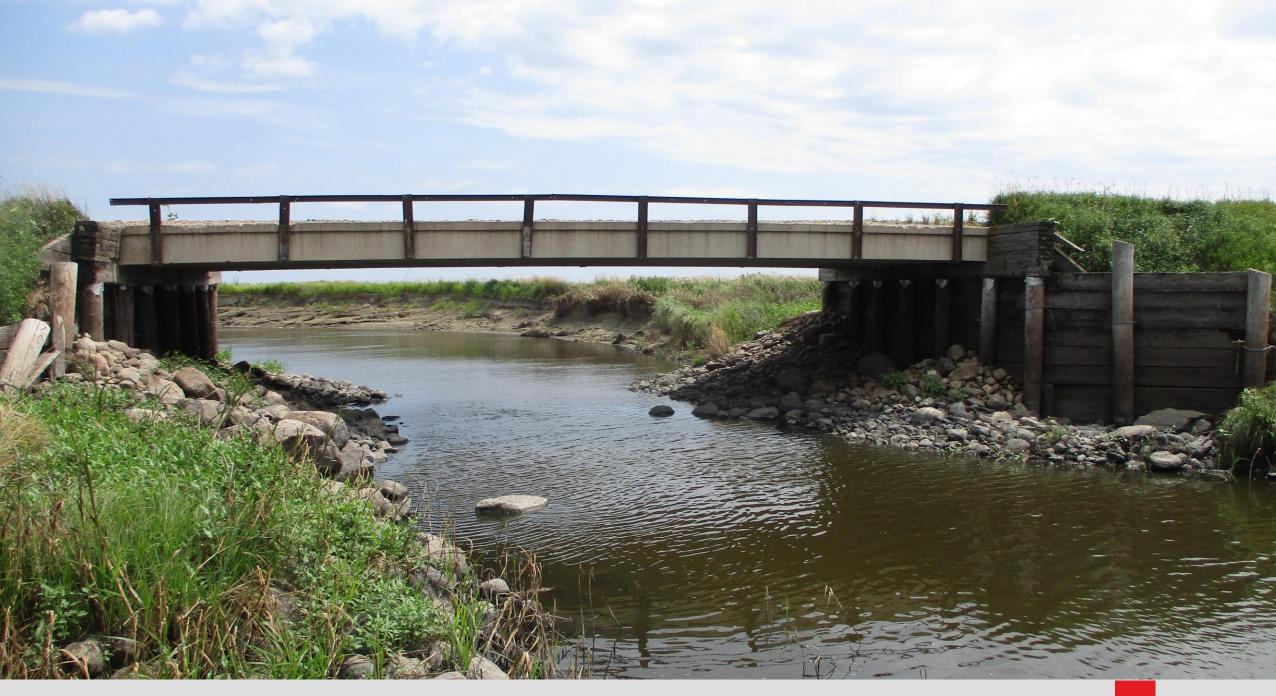
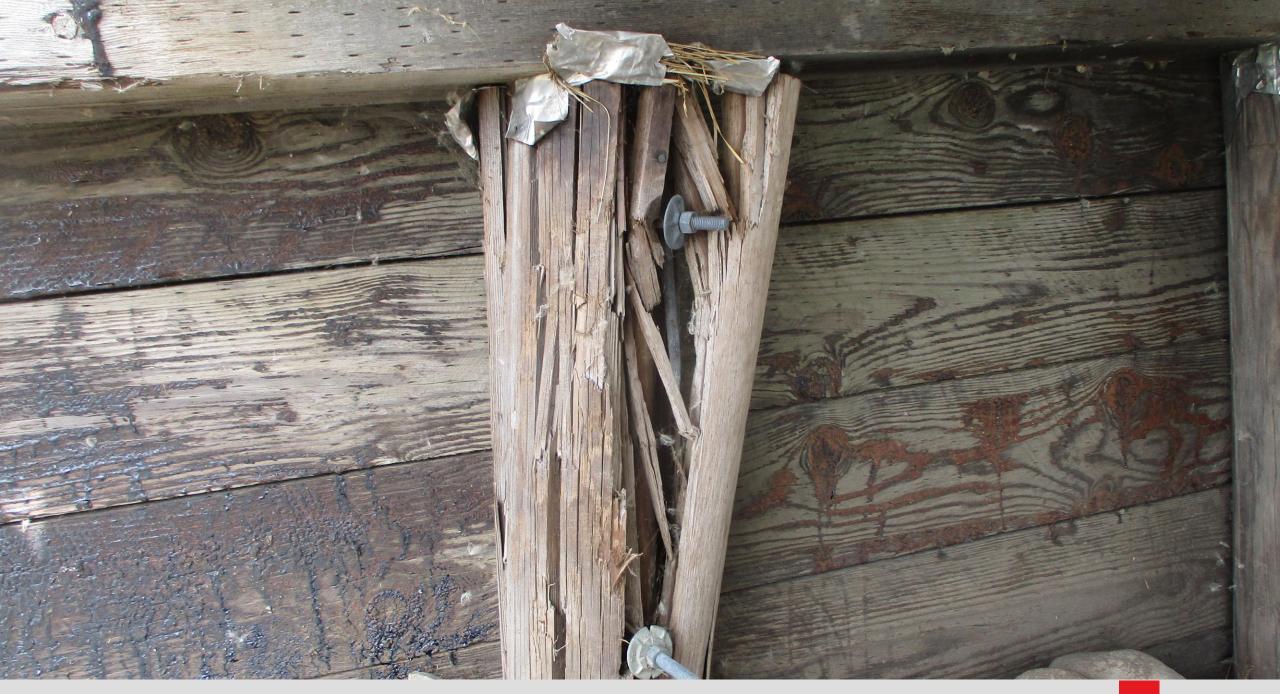
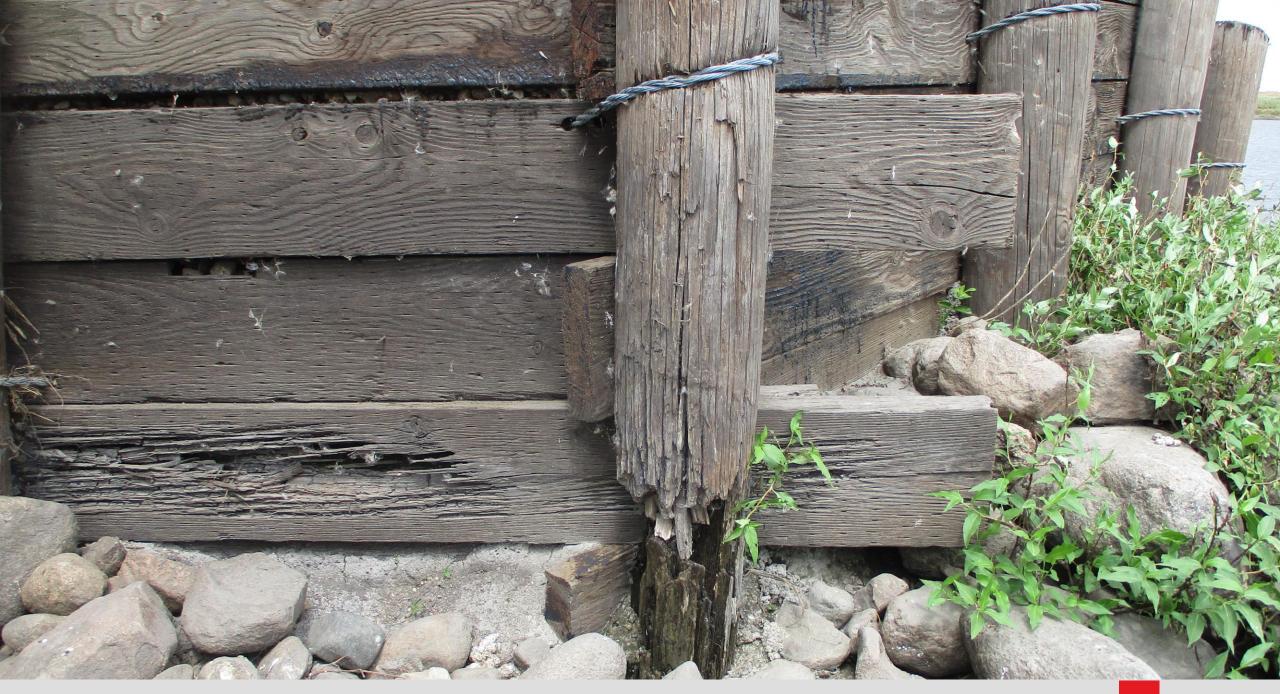
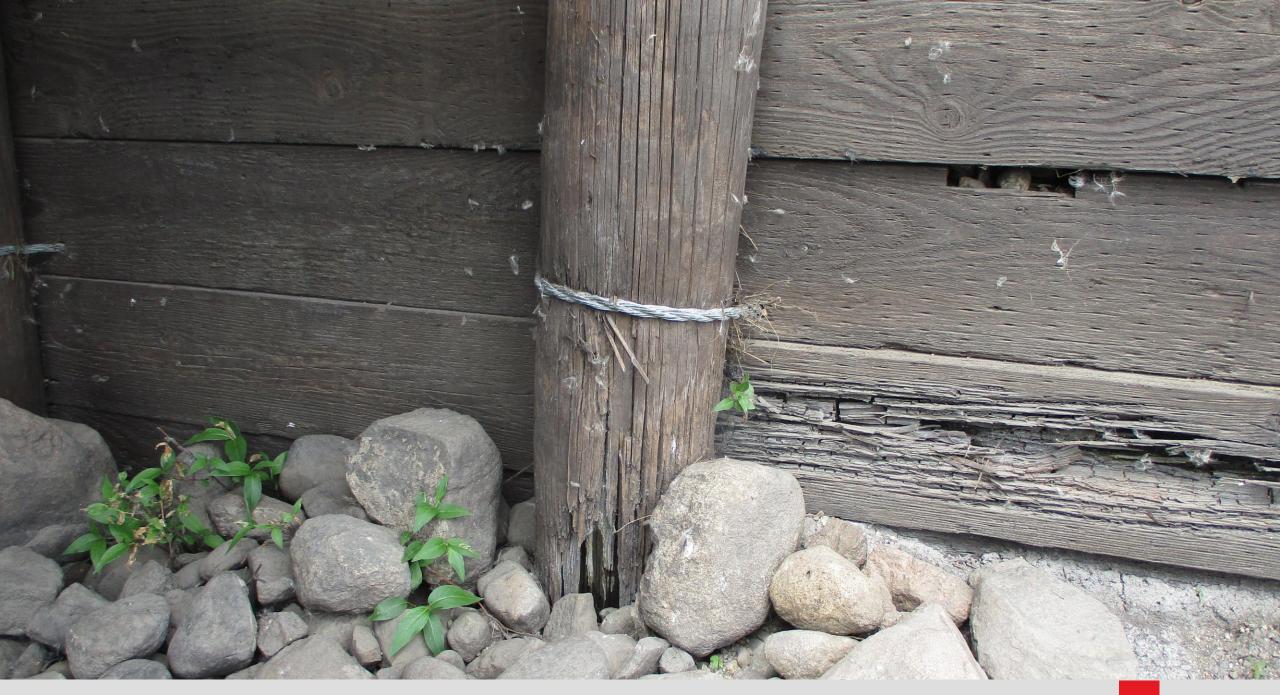
- » Major Repairs Recommended on 6 bridges
 - Bridge Number 30-280-198 (Double Tee/Timber Abut) Ice damage to piles, place concrete collars around piles.

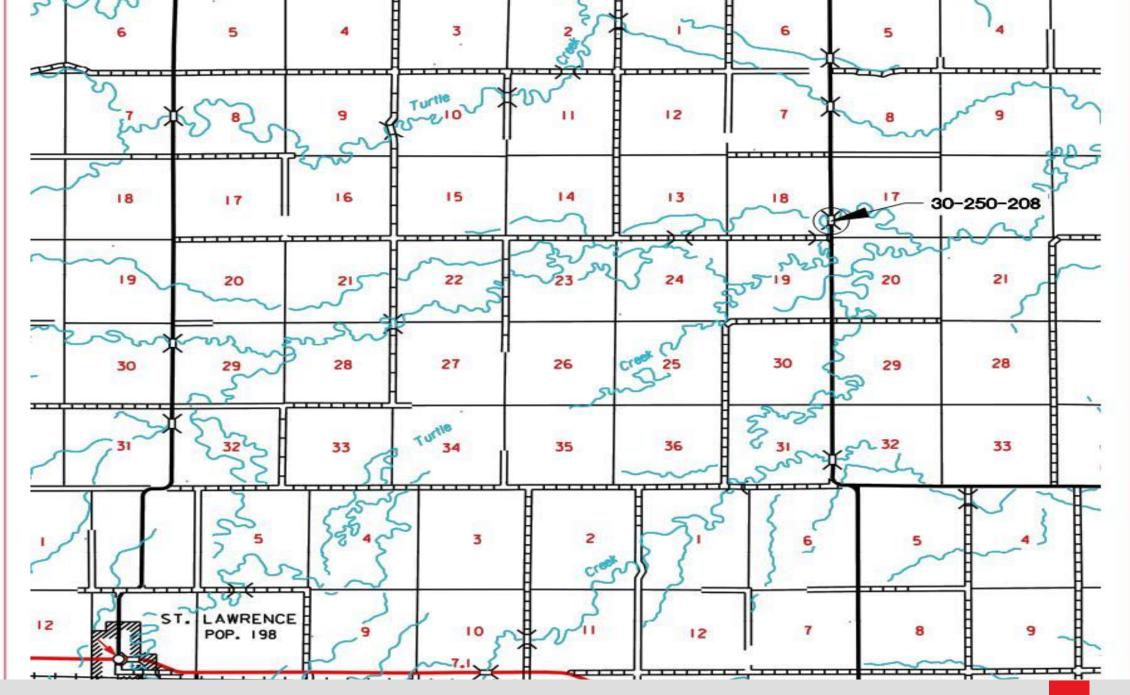
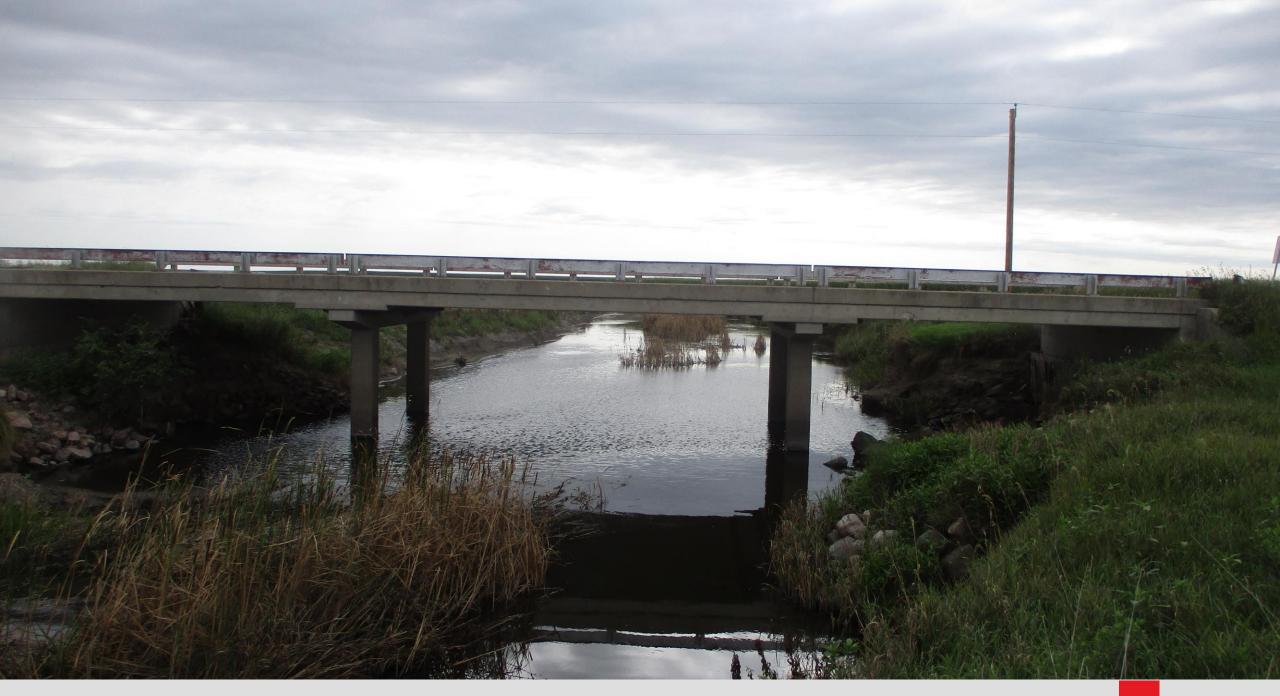
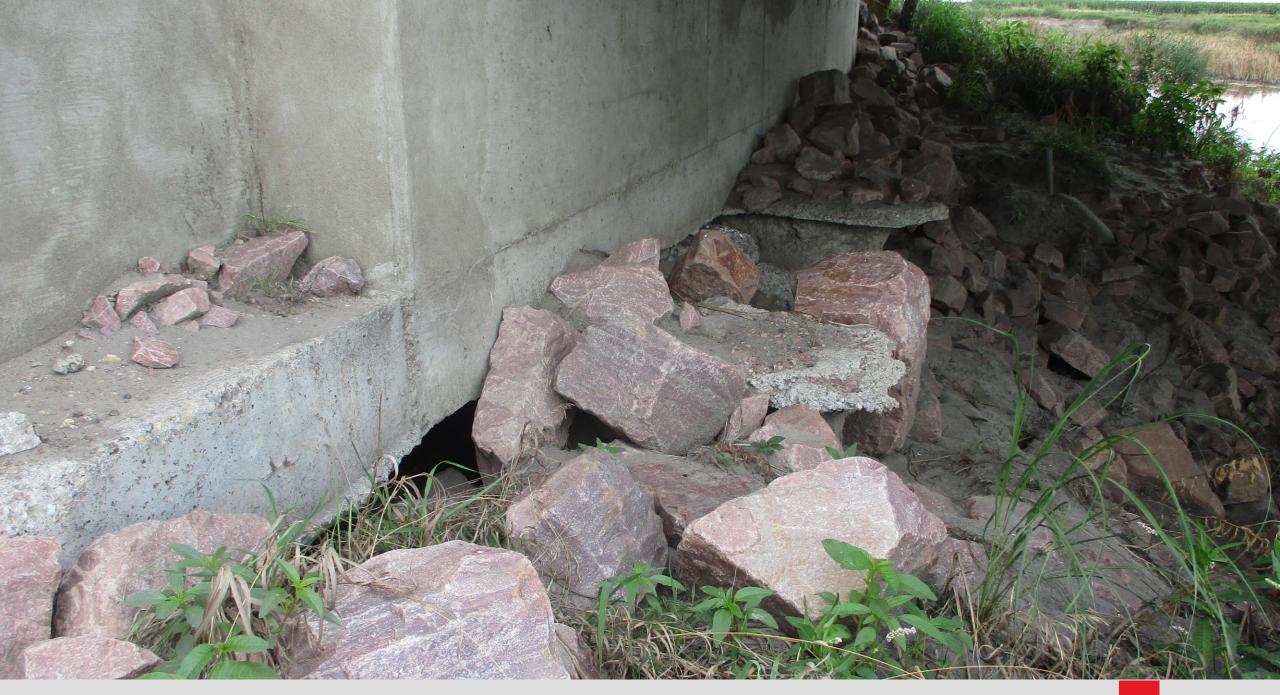
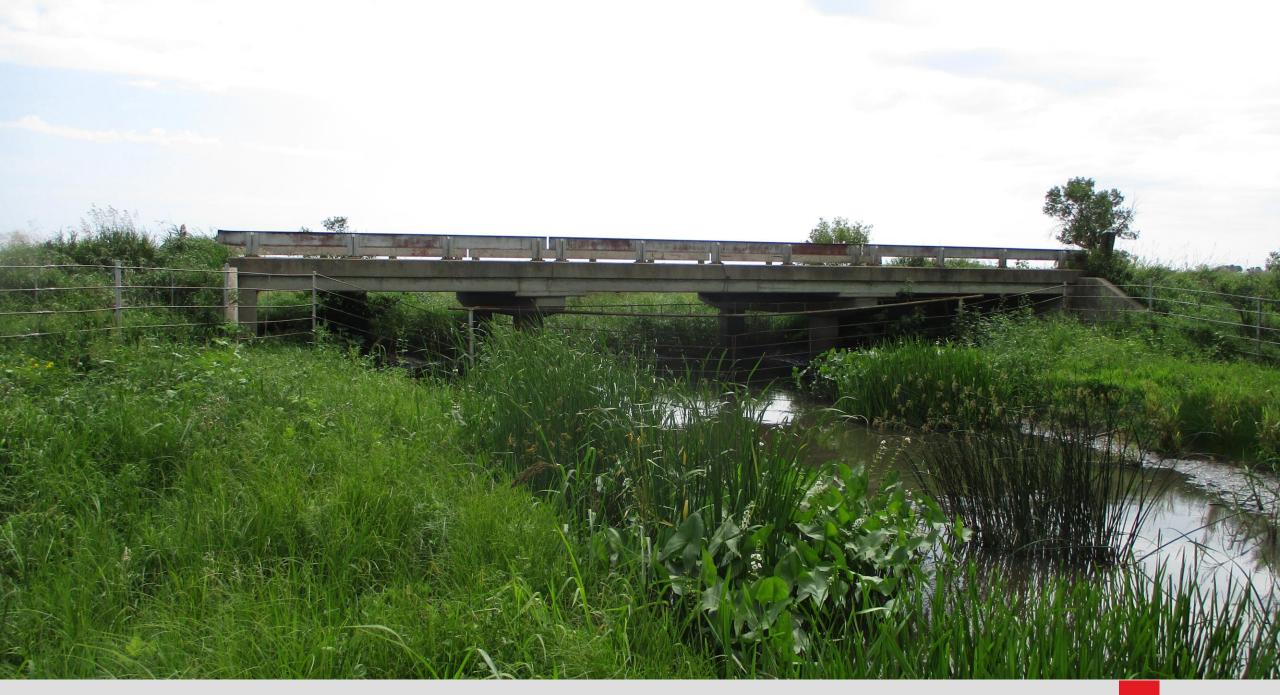
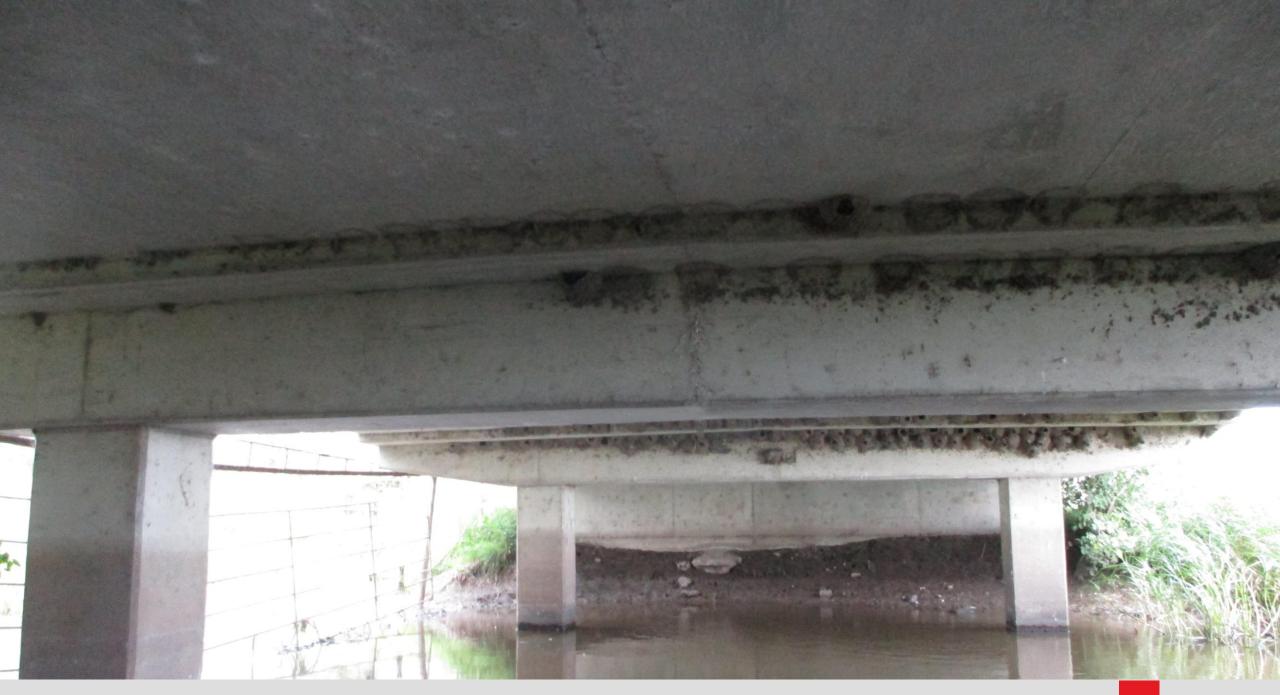
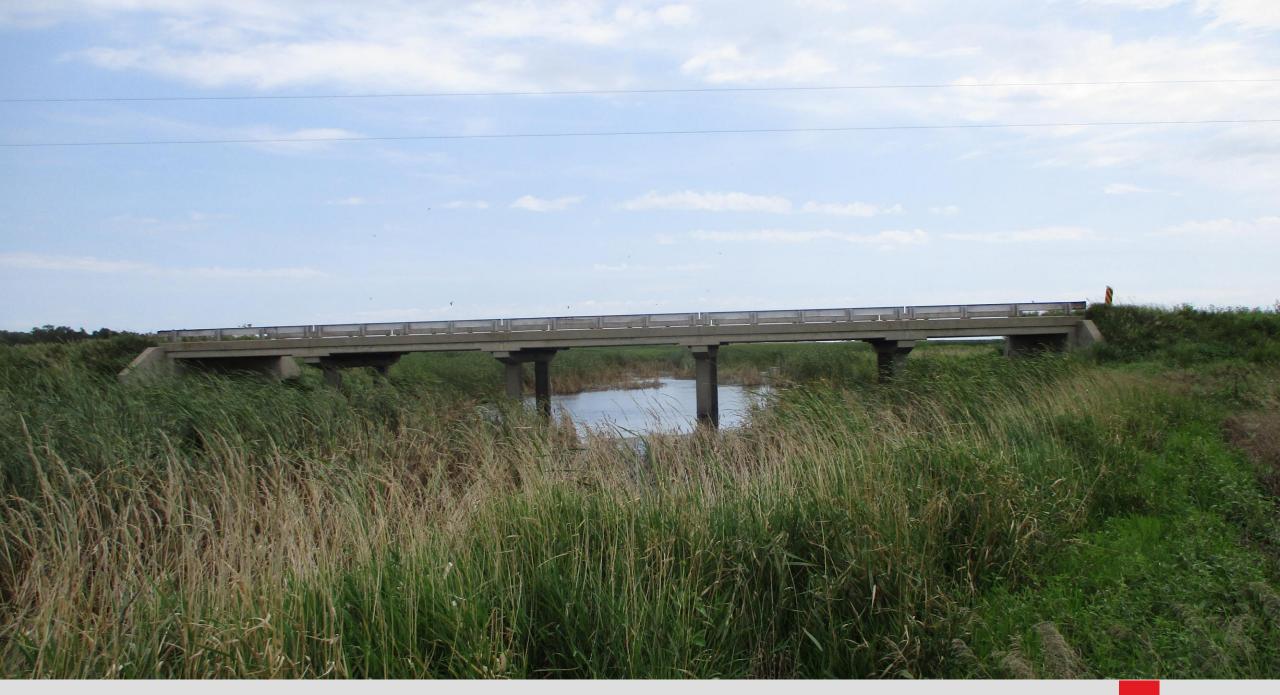
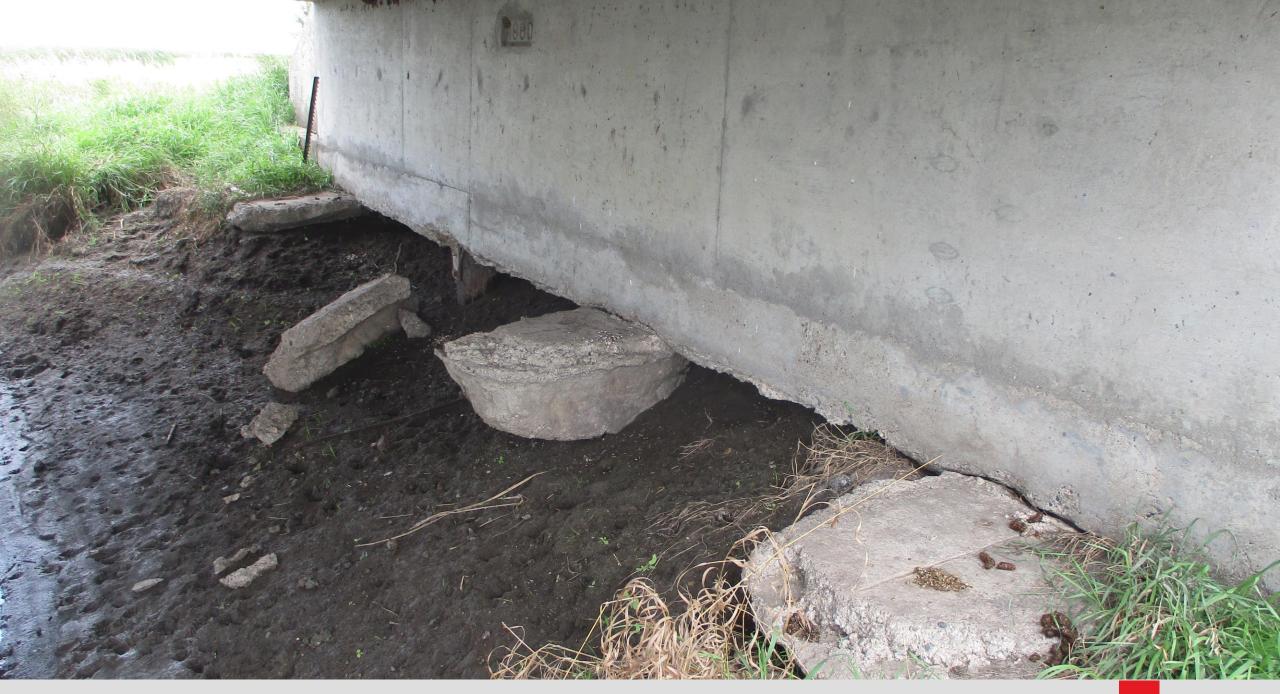
- » Major Repairs Recommended on 6 bridges (Cont.)
 - Bridge Number 30-250-189 (Concrete Slab) Undermined Abutments- Place flowable fill under abutments and place fabric/riprap on berm slopes.
 - Bridge Number 30-250-194 (Concrete Slab) Undermined Abutments- Place fabric/riprap on berm slopes.
 - Bridge Number 30-250-208 (Concrete Slab) Undermined Abutments- Place flowable fill under abutments and place fabric/riprap on berm slopes.
